Vigilance and fast action can help deter ATM skimming fraud

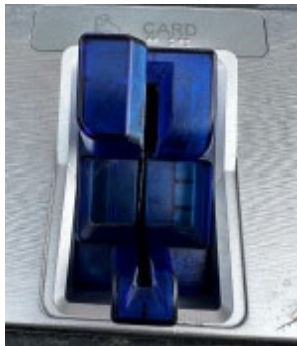
To the normal eye, a credit union member would not know that a skimming device resides inside the card reader. Cards inserted into the machine may have felt “tight” being inserted into the machine but otherwise unnoticeable. Upon closer examination, you can see a thin piece of metal in the machine which is the internal skimmer. The device is inserted into the machine just as a normal debit card but is designed to remain inside.

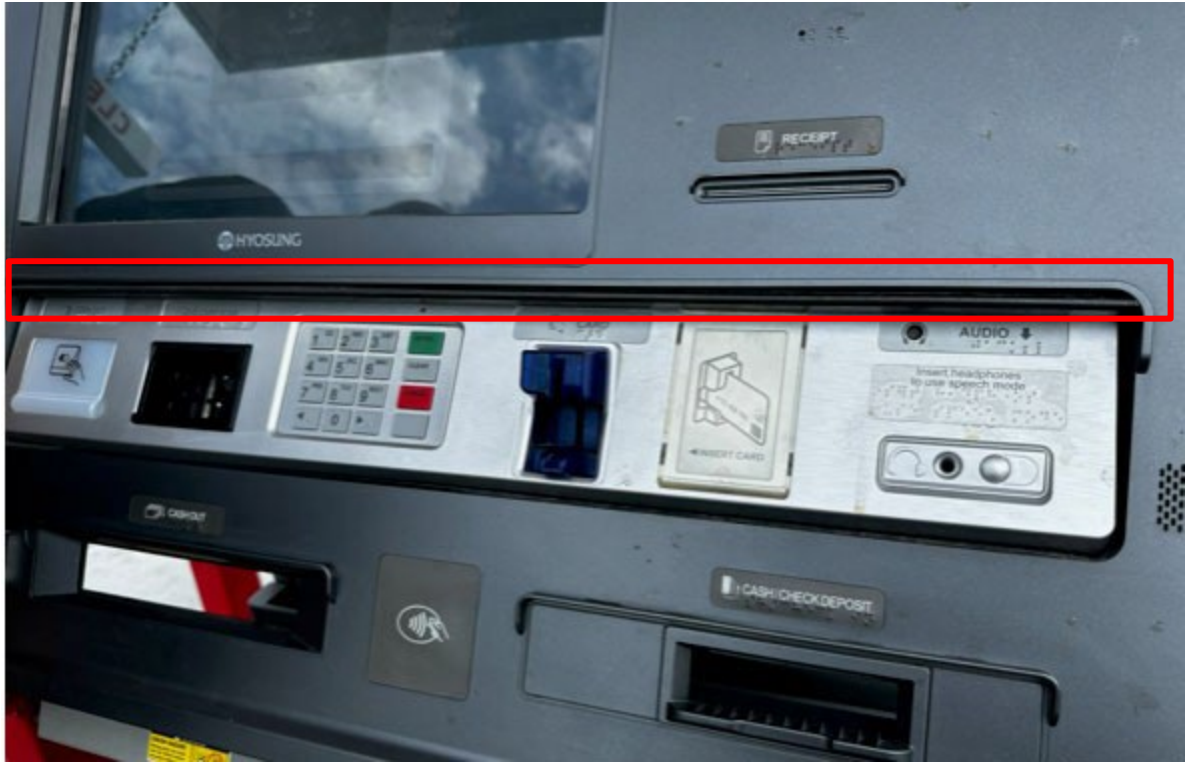
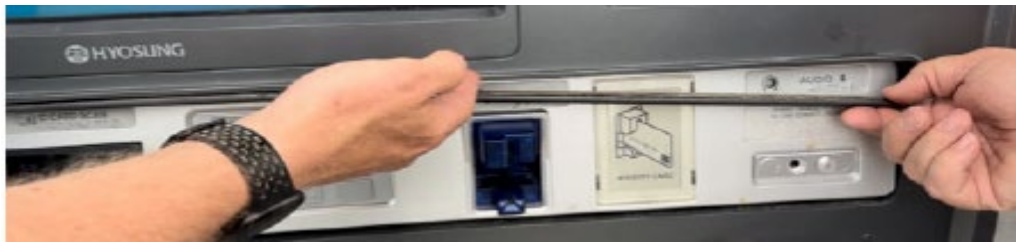
A false trim piece was applied to the front of the machine. The colors blended very well with the machine. The false trim was covering a built-in light on the machine.

The false trim piece was applied with an easy to remove adhesive.

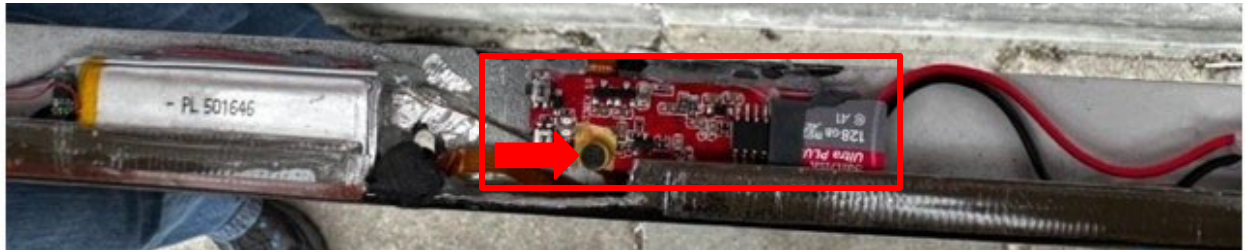
Once removed,

a very small camera with battery supplies and SD card were discovered. A hole in the bottom of the false trim was pointed at the keypad recording PIN entries.

The devices were removed from the ATM machine and turned over to the proper authorities. Based on information from the FBI, they believe they know who the fraudsters are but have been unable to apprehend them. They tend to work in one area for so long and then move on.
